Thermal Imaging Applied to Building Pathology Documentation: An Initial Modeling Approach

Angela Busheska, Leigh Jacobsen, Louisa Rose, Nara Almeida
 Department of Civil and Environmental Engineering at Lafayette College, Easton, PA.

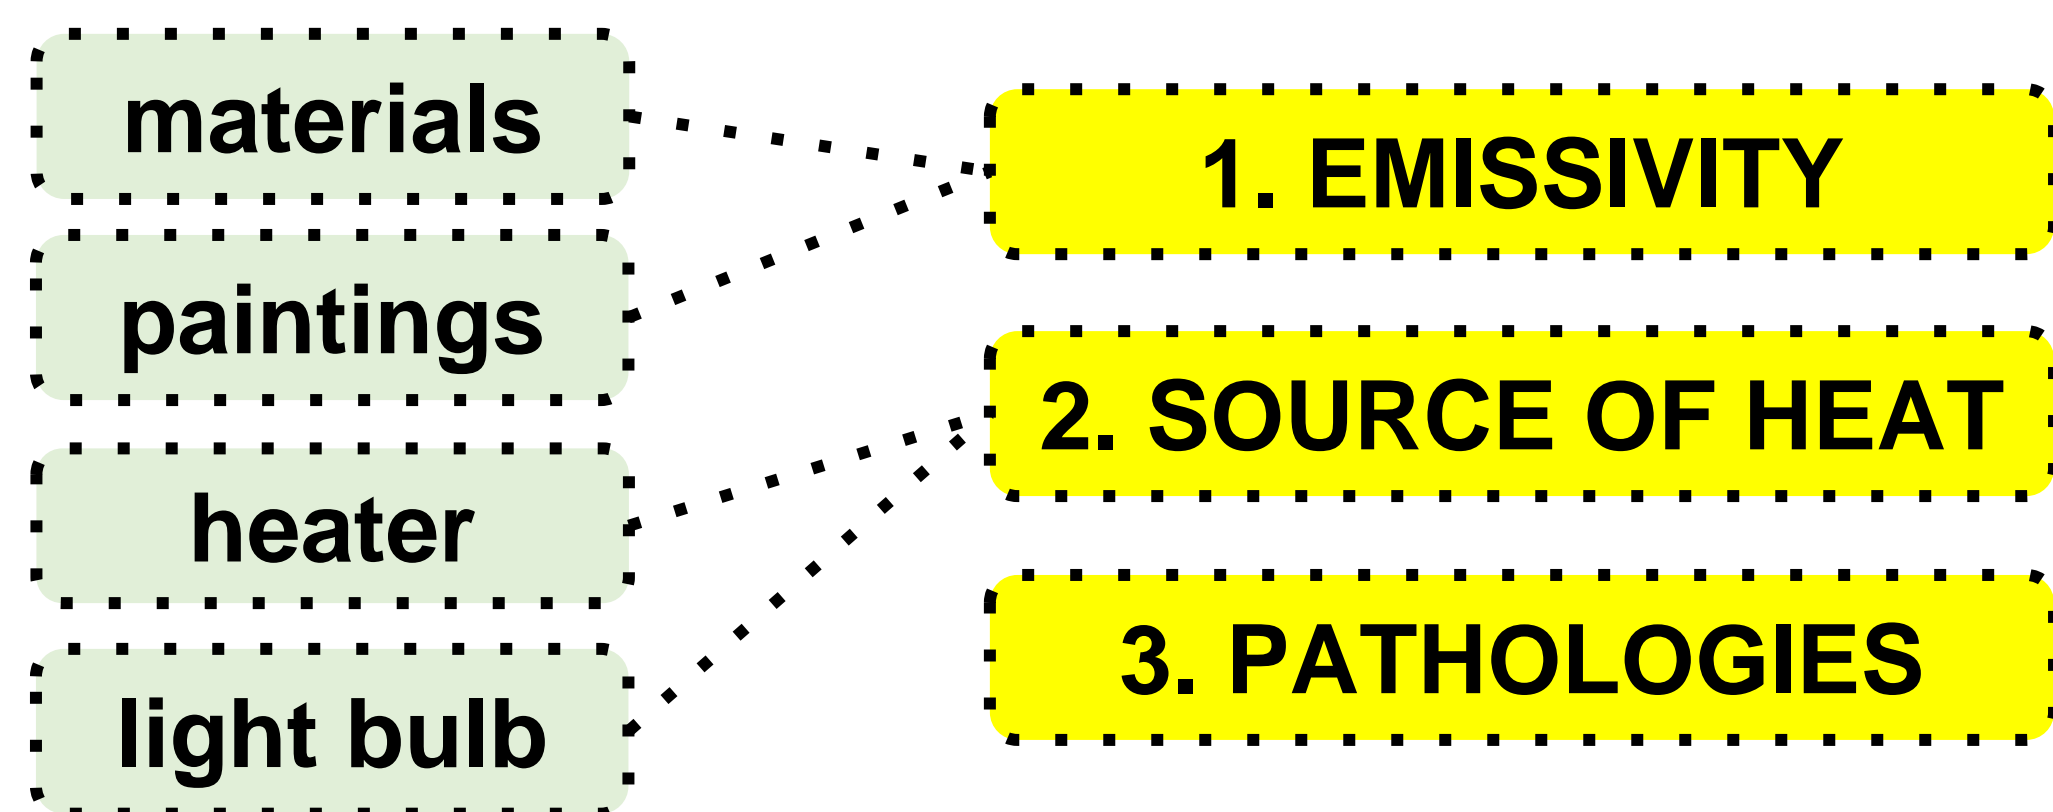
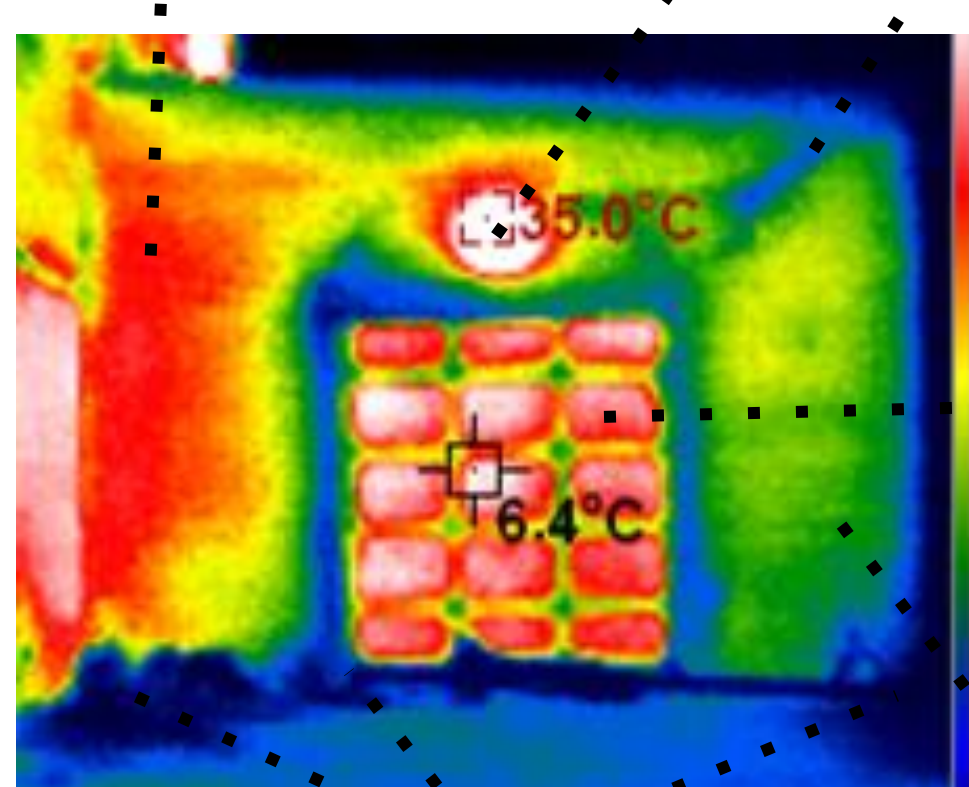
Figure 1: East Façade IRT Image – Method

- Brick (0.93)
- No paint
- heater
- Light bulb
- Crack

- Glass (0.94)
- No paint
- No heater
- Brick (0.93)
- No paint
- No heater
- Humidity (capillarity)

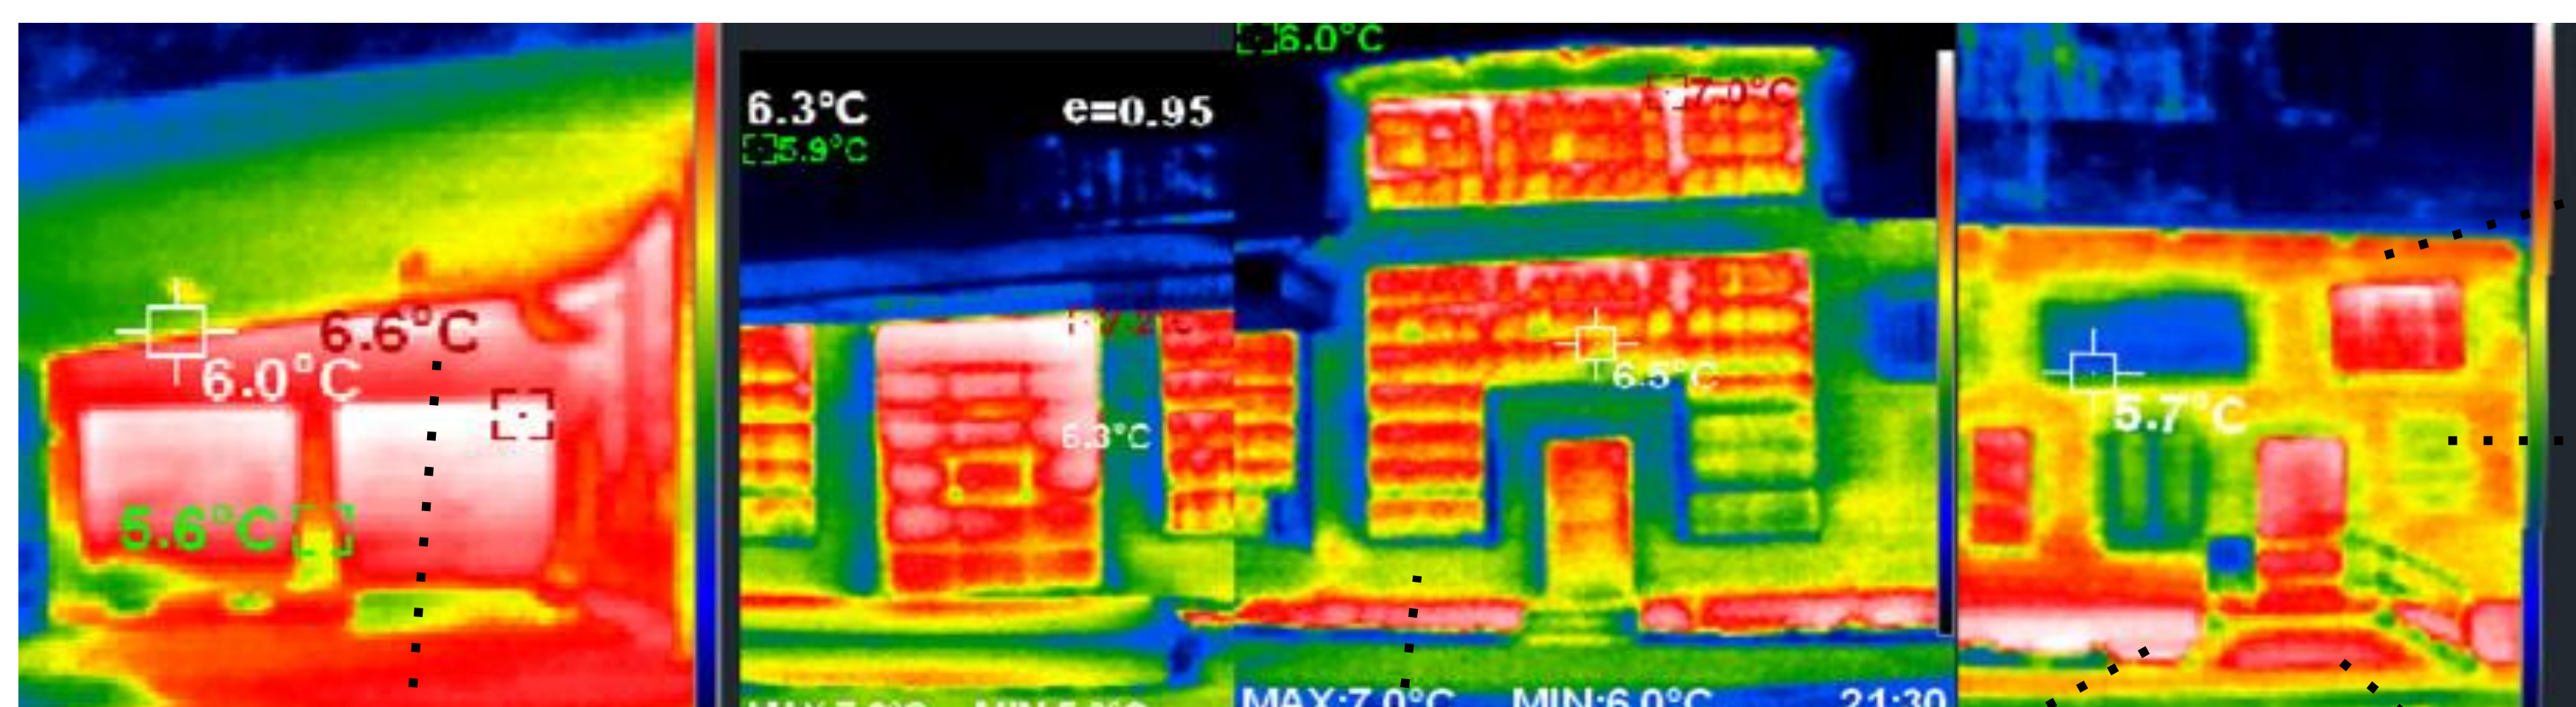
Figure 3: South Façade Infrared Thermal Images – Compilation

- Concrete block
- Light color
- No heater

- Brick
- No paint
- No heater

- Concrete
- Paint
- Heater

- Concrete
- No paint
- Heater

- Brick
- No paint
- Heater
- Brick
- Paint
- Heater
